**CANADIAN FORCES  
FLIGHT SAFETY INVESTIGATION REPORT (FSIR)**

**FINAL REPORT**

**FILE NUMBER:** 1010-CT114142  
**DATE OF REPORT:** 29 January 2002

**AIRCRAFT TYPE:** CT114142 Tutor  
**DATE/TIME:** 0857 local 10 April, 2001  
**LOCATION:** 19 Wing Comox, Runway 29  
**CATEGORY:** "B" Category accident, No injury

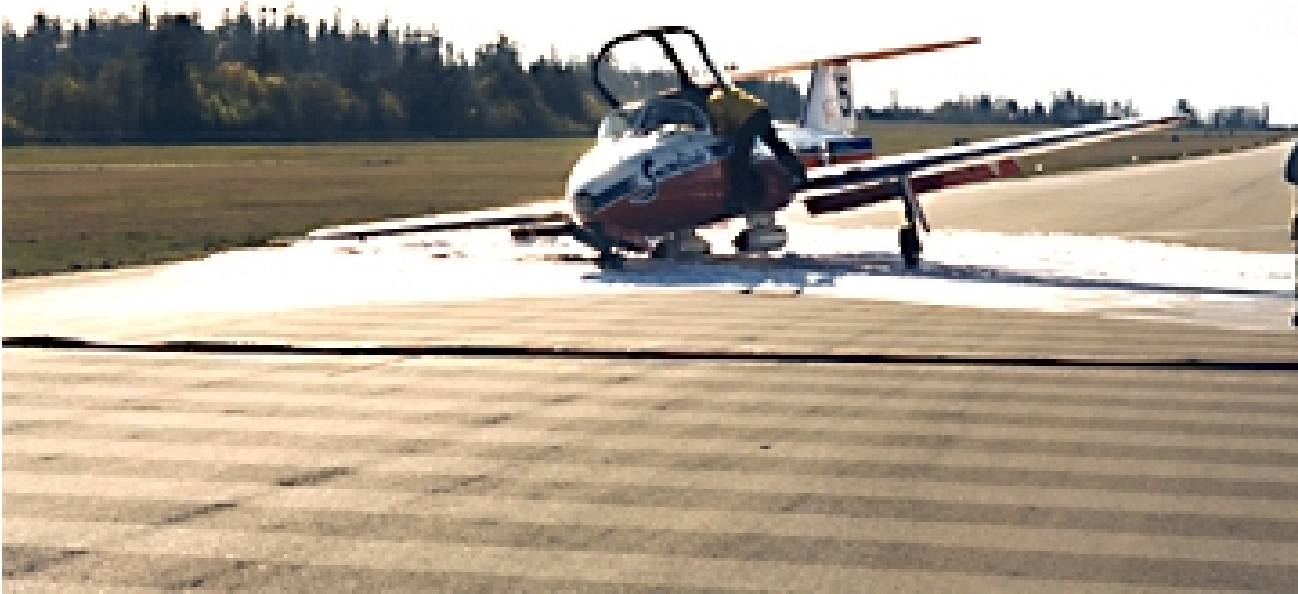
Photo 1: Aircraft after coming to a rest on runway.

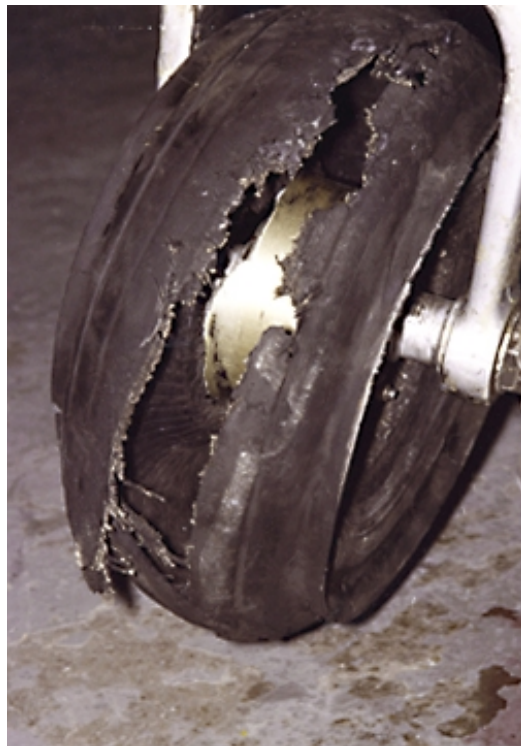
Nose Gear: The nose gear was fractured at the right hand mounting point, with damage to the landing gear door. The nose gear tire was blown and the wheel had disintegrated. (Annex A, Photo 2)

Photo 2: Nose gear and tire damage

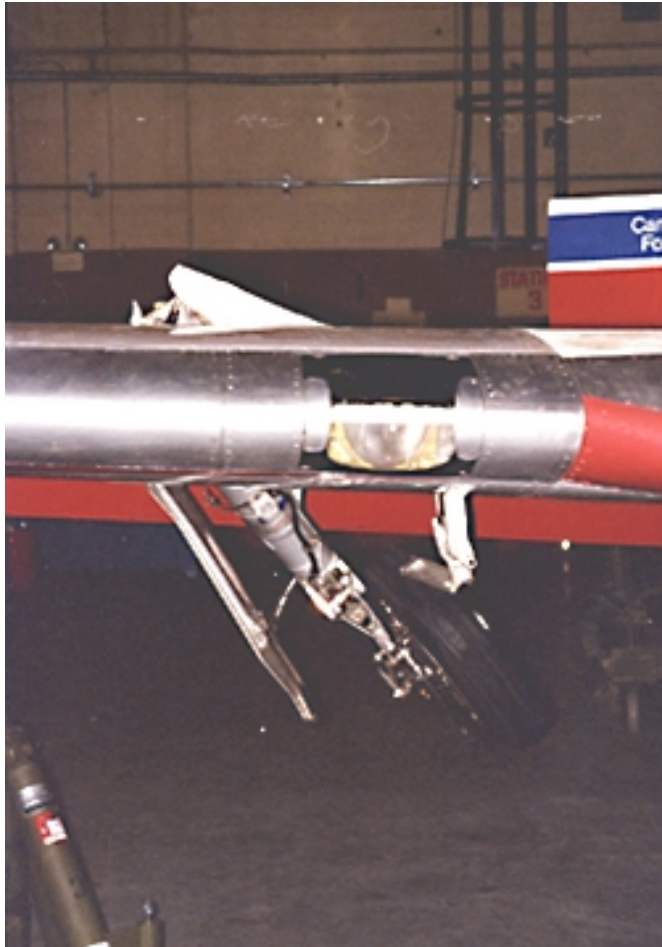
Right-hand Landing Gear: The rear landing gear mount was fractured and forced up through the skin of the upper wing surface. The gear actuator was broken at the eye end. (Annex A, Photo 3 and Photo 4)

Photo 3: Right-hand main landing gear

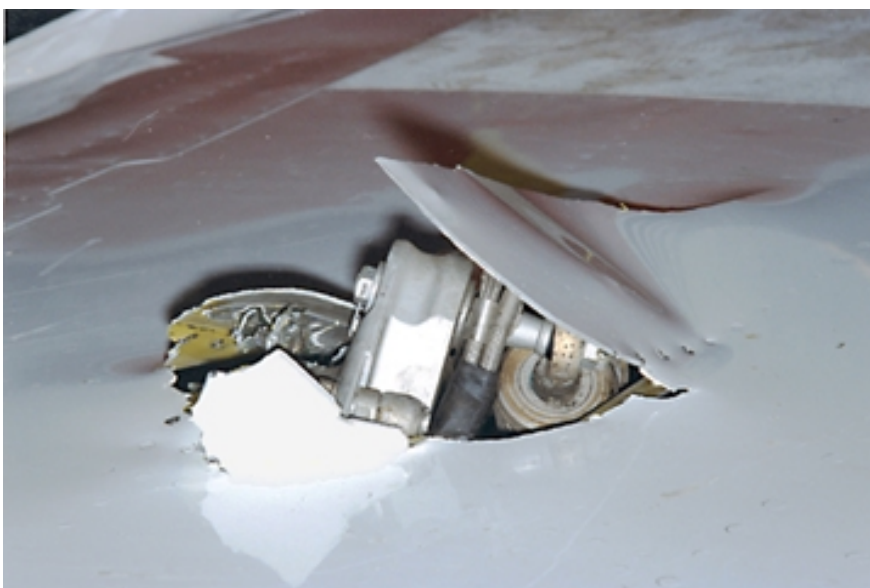
Photo 4: Right –hand main landing gear forced through upper surface of right wing.

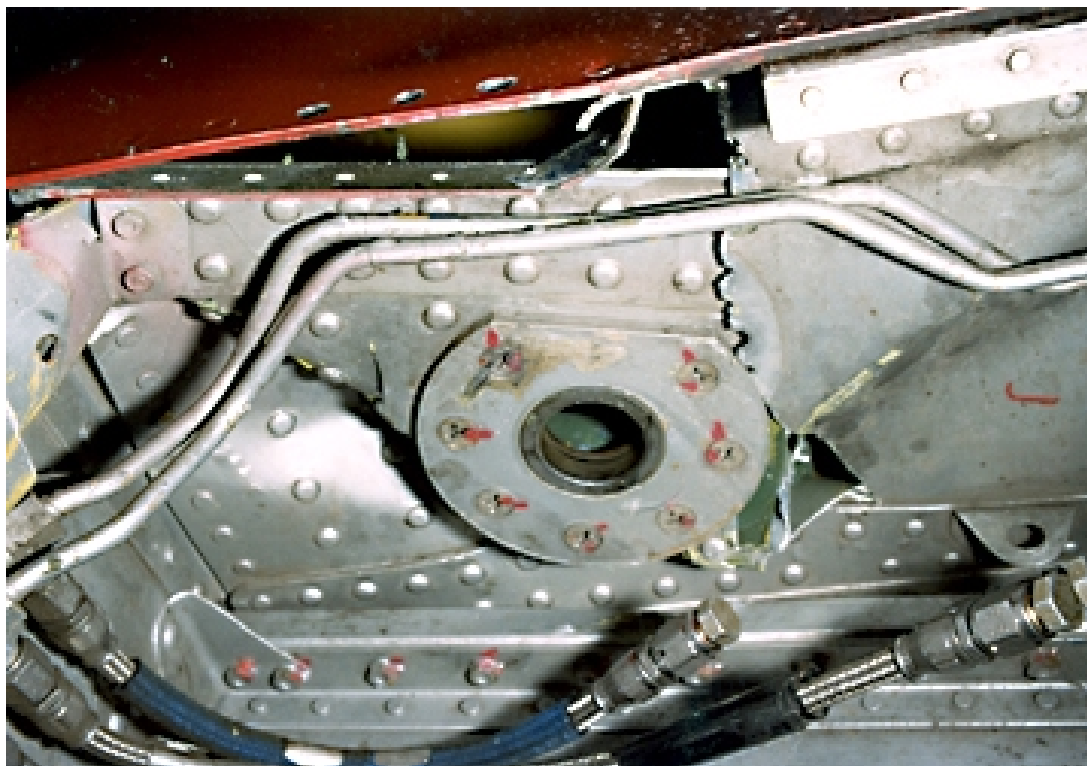
Left-hand Landing Gear: The rear trunnion was fractured at the bulkhead. The landing gear door was forced upward and backward at the hinge point, and the aircraft skin on the upper wing surface above the landing gear mount was visibly buckled. (Annex A, Photo 5)

Photo 5: Left-hand landing gear mount

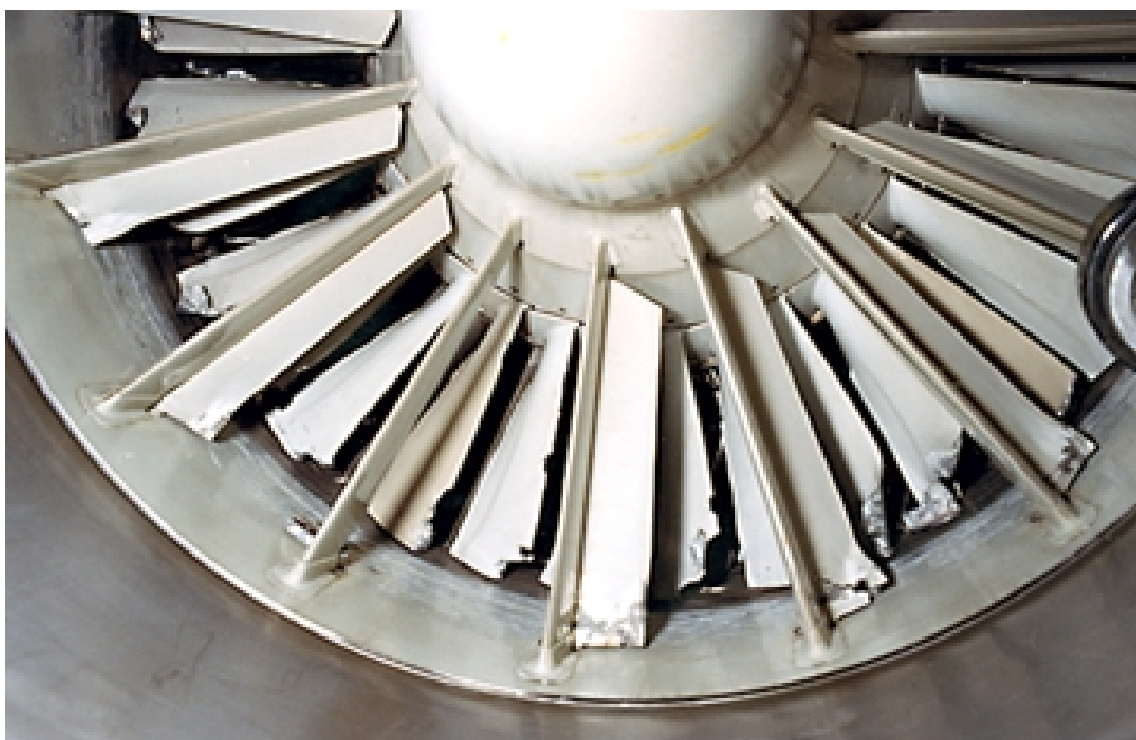
Engine: The J-85 engine showed visible signs of foreign object damage (FOD) to at least the second stage of compression. (Annex A, Photo 6)

Photo 6: Engine damage

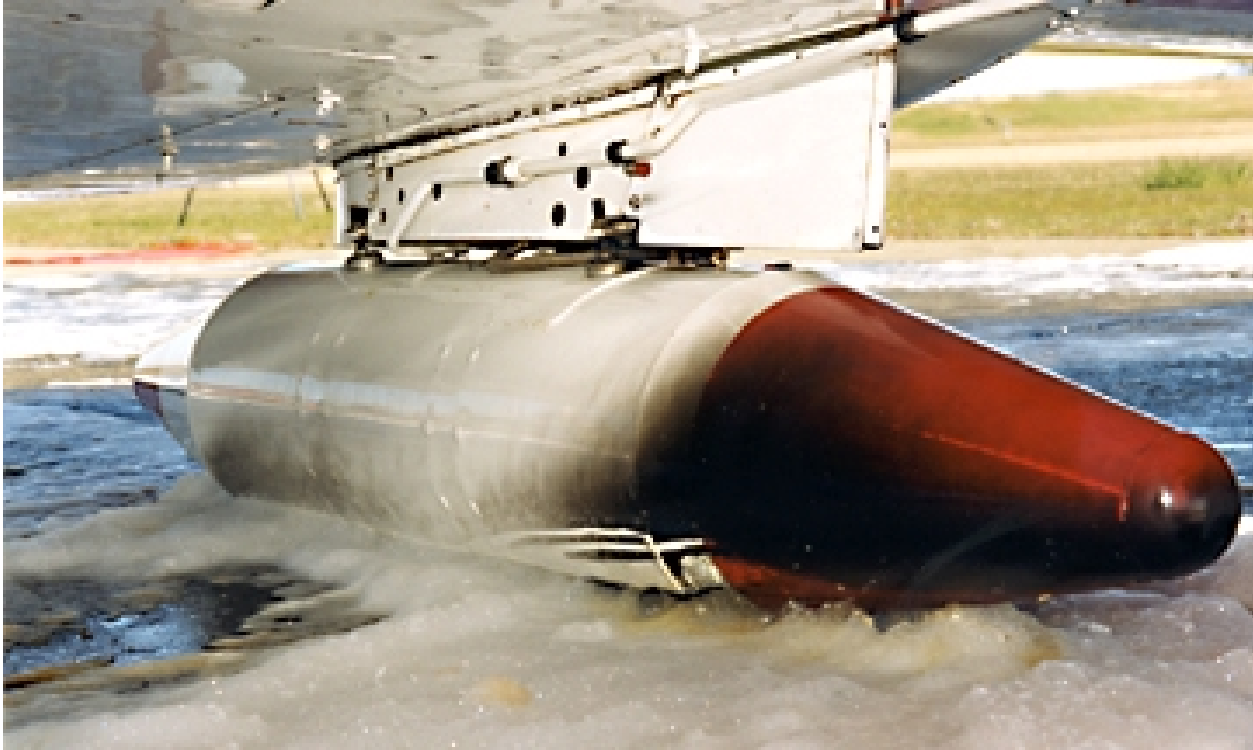
Right-hand smoke tank: The right-hand smoke tank showed signs of damage from scraping along the runway and from a small fire created by leaking diesel fuel. (Annex A, Photo 7 and Photo 8)

Photo 7: Right-hand smoke tank

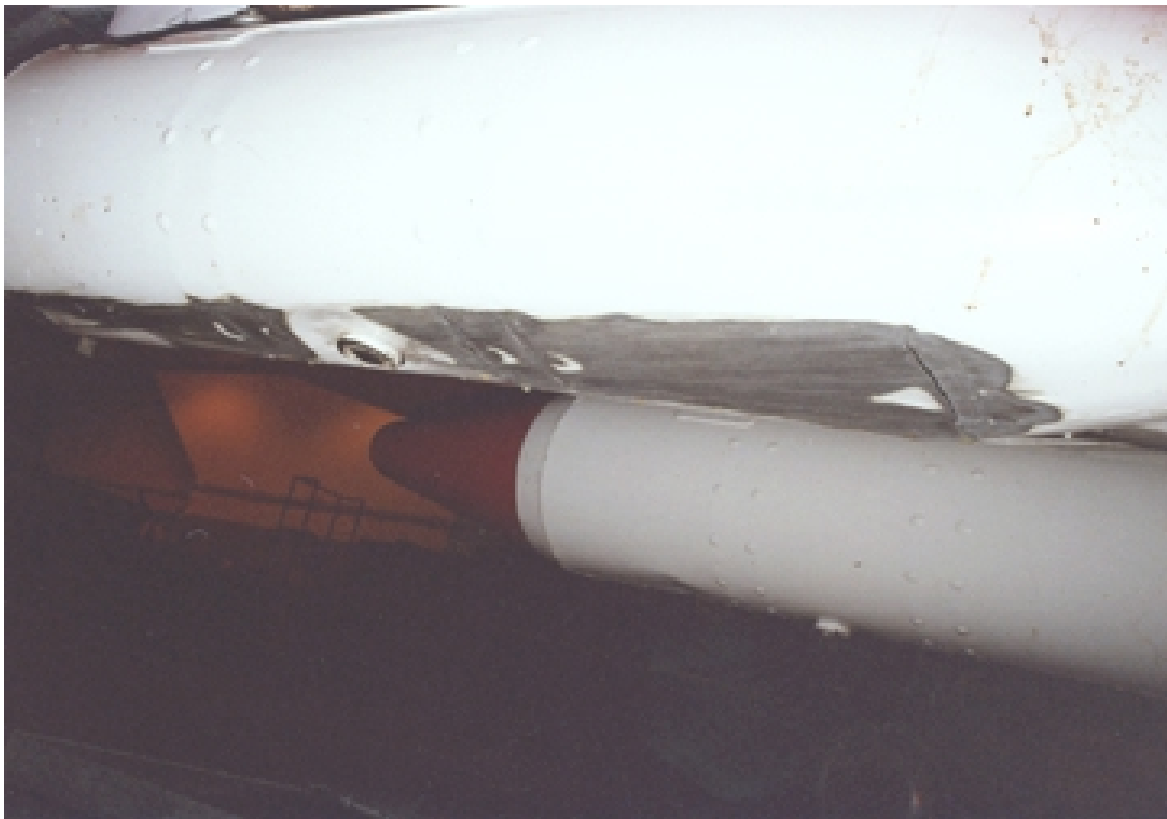
Sparks, which were created from the aircraft sliding on the right-hand smoke tank, ignited diesel fuel leaking from the bottom of that tank. The fire was short-lived and extinguished itself. Fire retardant foam was sprayed on the underside of the aircraft by a firefighting vehicle as it arrived at the accident site. This was primarily done due to the presence of diesel fuel under and in the vicinity of the aircraft.

Photo 8: Right-hand smoke tank underside

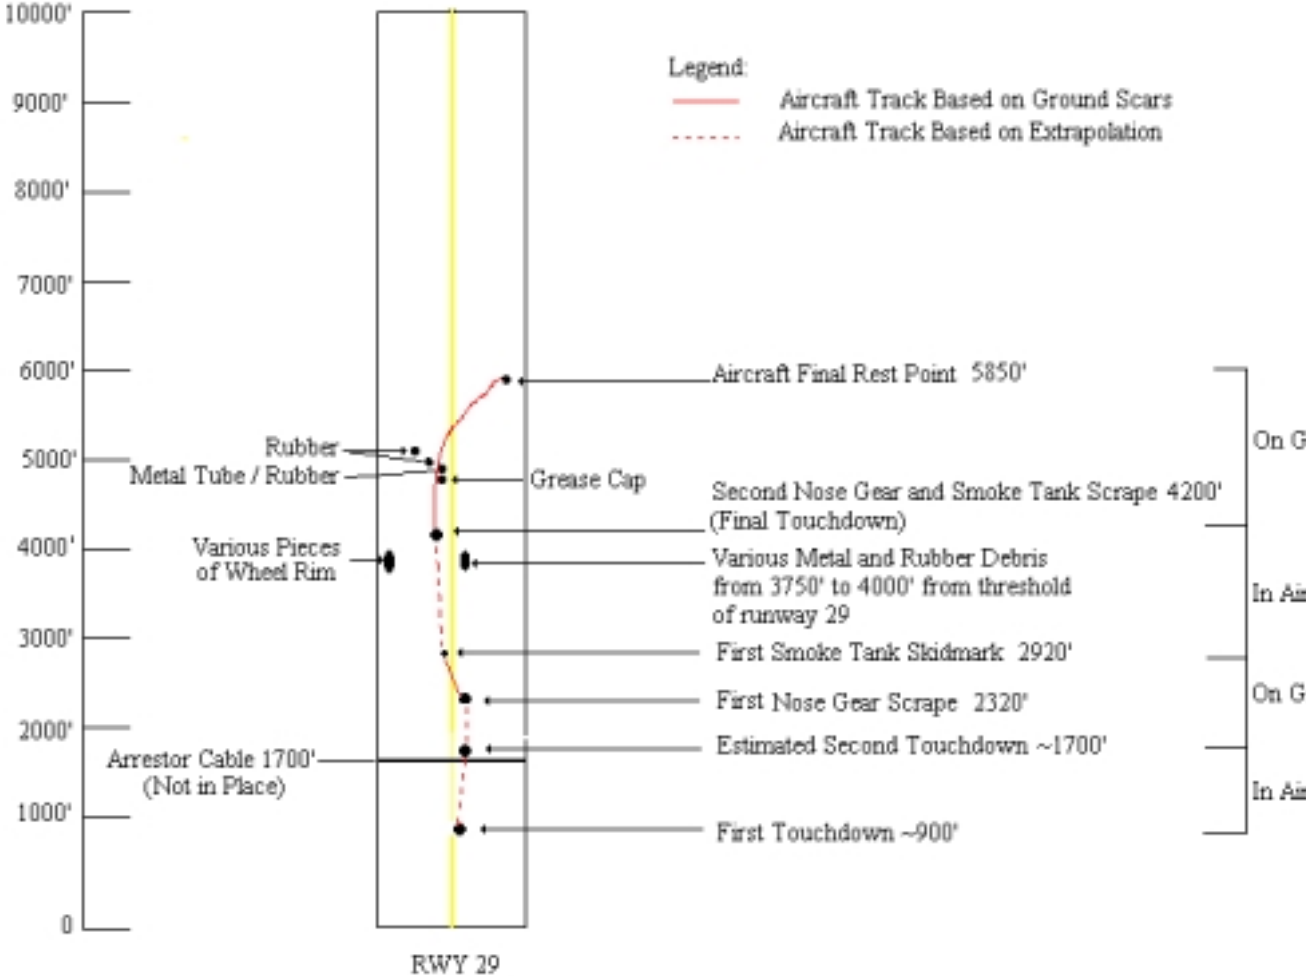
Annex B: Reconstructed landing pattern and wreckage diagram

The aircraft's initial touchdown point was approximately 900 feet from the threshold of runway 29. The aircraft's final resting point was approximately 5850 feet from the threshold of runway 29. The wreckage was moved from its original resting point within a few hours of the accident to allow the use of the runway for recovering aircraft at 19 Wing. (Annex B)
